Assessment of potable water quality in Sitio Sarimao, Pasacao, Camarines Sur: Physicochemical and microbiological analysis

Central Bicol State University of Agriculture - Pasacao, Philippines (christopherjr.pamarang@cbsua.edu.ph)

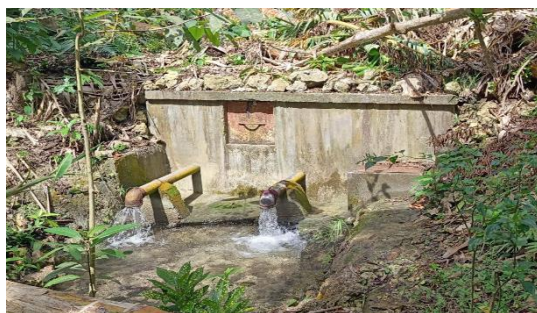
Sample Stations - Three (3) sampling stations were established within Sitio Sarimao to collect water samples from the primary sources utilized by the local community. These stations were strategically selected to represent variations in elevation, surrounding land use, and potential exposure to environmental and anthropogenic influences. Station 1 is located at a higher elevation and consists of a Small Water Impounding System (SWIS) surrounded by trees and diverse vegetation (Figure 2). The presence of dense flora provides natural protection to the water source, potentially reducing direct contamination while also influencing physicochemical characteristics through organic matter input.

Figure 2. Sampling Station 1, Small Water Impoundment System

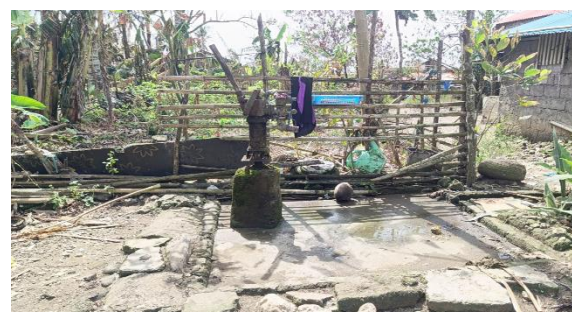
Figure 3. Sampling Station 2, Artesian Well

Stations 2 and 3 are situated in the lower portions of the sitio and are classified as water pump sources (artesian well). Station 2 is located within a densely populated area and is heavily utilized for domestic purposes, livestock activities, and recreational use (Figure 3). Due to the intensity of human and animal activities in the vicinity, this station is more susceptible to contamination from surface runoff and improper waste disposal. Station 3, positioned at the lowest elevation, is located near a roadway and a newly constructed seawall (Figure 4). Its proximity to infrastructure development and coastal modifications increases the potential for environmental stressors, including urban runoff and saltwater intrusion, which may affect water quality.

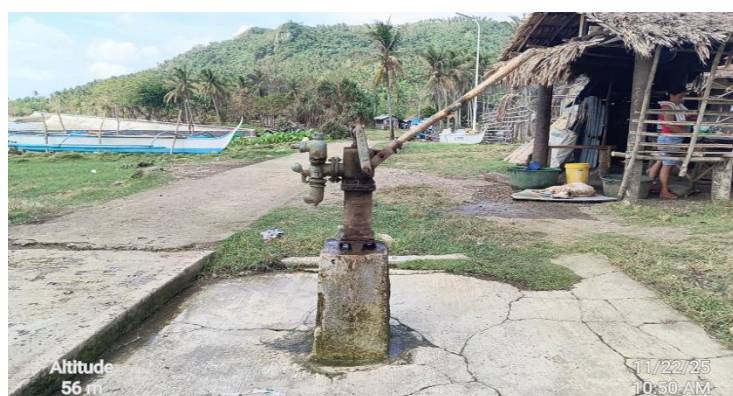
Figure 4. Sampling Station 3, Artesian Well

Additionally, livestock were located about 10 meters from the water source, and nearby residences increase the potential for microbial intrusion. Although the physicochemical characteristics of Station 3 may still meet acceptable limits, the observed conditions suggest a high likelihood of microbial contamination, which renders the water unsuitable for drinking. Saltwater intrusion in coastal areas like Sitio Sarimao occurs when seawater enters freshwater aquifers due to groundwater over-extraction or rising sea levels, reducing freshwater quality and usability. This process increases salinity, which disrupts aquatic ecosystems by harming freshwater species and reducing biodiversity, linking it to SDG 14 (Life Below Water).

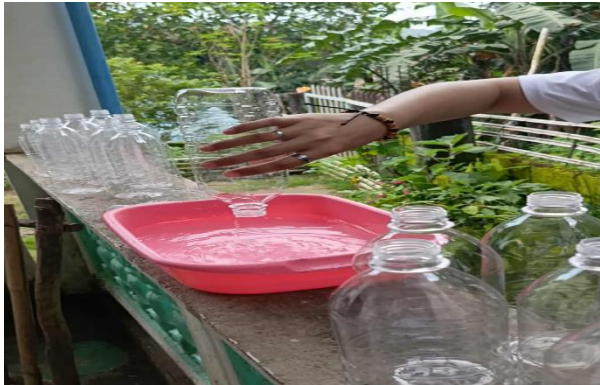
Data Gathering Procedure - This study followed EMB–DENR Water Quality Monitoring Manual Volume I and MNWD bacteriological testing protocols to ensure proper water sample collection and accurate analysis. Three sampling sites in Sitio Sarimao were identified, and sterilized containers were used to prevent contamination

Figure 5. Container Sterilization

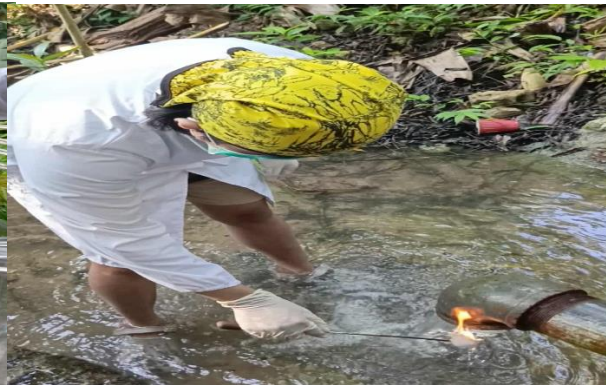
(Figure 5). Prior to sampling, water pipes were disinfected using sodium hypochlorite and flame-sterilized with 70% isopropyl alcohol (flFigure 6). Water was then collected after allowing it to flow briefly, ensuring proper handling and avoiding air bubbles to maintain sample integrity and reliable results.

Figure 6. Flaming The Nozzle of Water Source for 30 Seconds

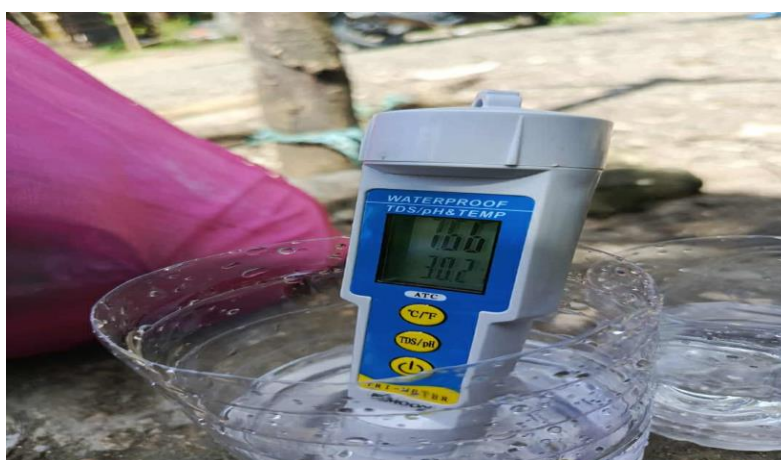
- pH meter used to determine the hydrogen ion concentration, indicating the acidity or alkalinity of the water. Water is on a scale from 0 to 14. A pH of 7 is neutral, below 7 is acidic, and above 7 is basic. It is important because extreme pH levels can affect water safety and the health of organisms. The pH test performed three times per sample, and the average taken for more accurate data presentation (Figure 7).
- Salinometer measure the salinity, or the amount of dissolved salts present. The salinity of each sample tested three times, and the average result will be used for accuracy (Figure 8).
- To measure the temperature, thermometer used on-site to determine the current temperature of the water sources, the test performed three times, and average for accurate data collection (Figure 9).

Figure 7. Measuring of pH, Using pH Meter

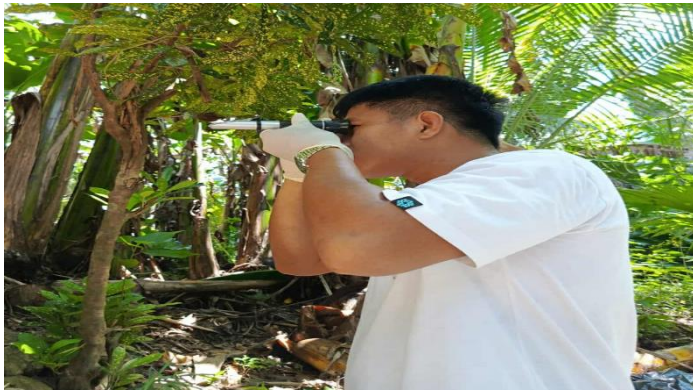
Figure 8. Salinity Measurement, Using Salinometer

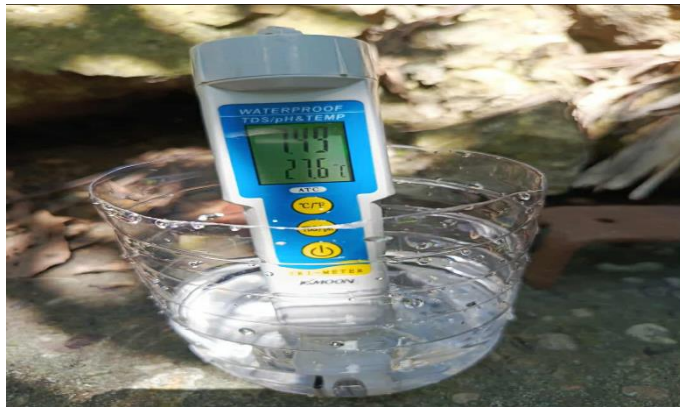
Figure 9. Measuring of Temperature, Using pH Meter in Temperature Reading

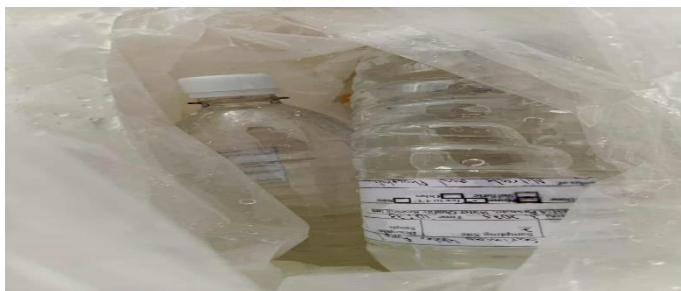
After collection, water samples were properly stored, placed in ice boxes, and promptly transported to the respective laboratories to preserve sample integrity and minimize changes in microbial content (Figure 10). The results were then evaluated and compared with the standards set by DENR Administrative Order (DAO) 2016-08 and the Philippine National Standards for Drinking Water (PNSDW) to determine the suitability of the water for human consumption.

Figure 10. Sample Preservation
